HOME INSPECTION REPORT

Hawkeye Home Inspections

BUILDING DATA

Approximate Age: 54 years
Style: Split level
General Appearance: Satisfactory
Main Entrance Faces: East
Weather Condition: Raining
Temperature: 50-60°F
Ground cover: Wet

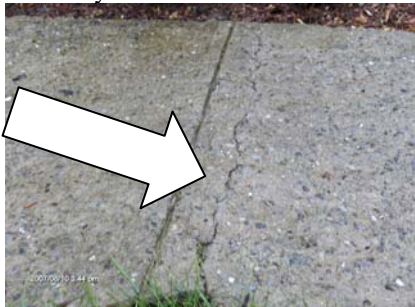
Walkways had some cracks that need repair but useable.

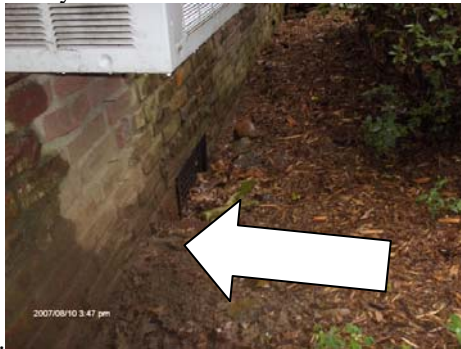
Deck posts were buried in the ground and should be monitored in the future for signs of rotting otherwise appeared to be in satisfactory condition. Low areas next to the foundation at the front left and rear right of home need some

correction.

All surfaces of untreated wood need regular applications of paint or special chemicals to resist damage. Porch or deck columns and fence posts which are buried in the ground and made of untreated wood will become damaged within a year or two.

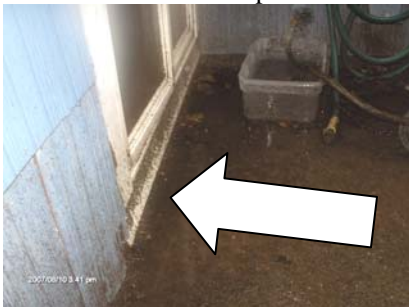
Recommend additional backfill to create a proper pitch away from the house. Patio is pitched toward the home; recommend repair or replacement as needed.

Patios that have settled towards the structure should be mud jacked or replaced to assure proper pitch. Improperly pitched patios are one source of wet basements.

Flower beds, loose mulched areas, railroad ties and other such landscaping items close to the foundation trap moisture and contribute to wet basements. To establish a positive grade, a proper slope away from the house is 1" per foot for approximately 5-6 feet. Recommend ground cover planting or grass to foundation.

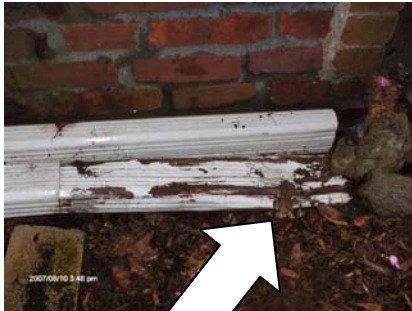
Flashing around chimneys, skylights and roof vents are completely covered with tar and could not be inspected; ongoing maintenance will be needed due to the tar cracking over time. Leader extension was crushed in the front of the home and needs replacing.

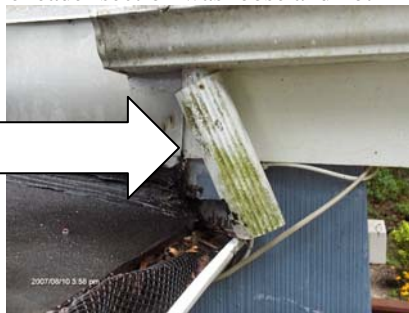
Rear middle leader section was loose and not lined up with gutter below and

needs to be re aligned and secured with hardware.

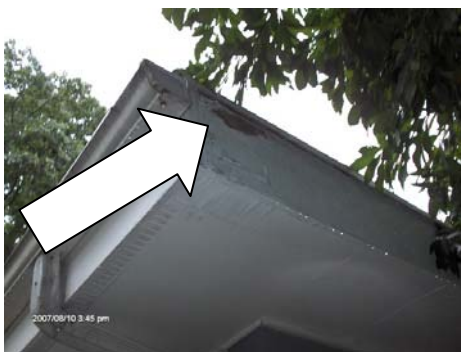
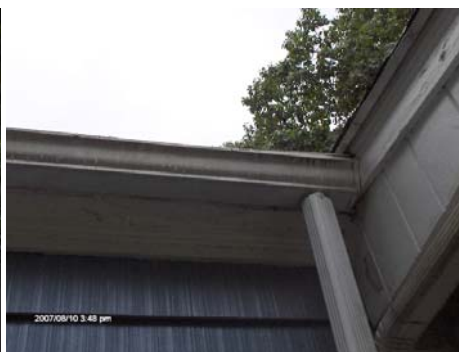
Some Ponding of water noted in gutters. Gutters may need some slight re pitching in a few areas. Siding had some dry rotted shingles at the rear left of home that need replacing from ground contact. Some screens are torn, repair as needed. Some wood trim boards, sills, soffit and fascia boards had chipping paint with some minor dry rot and need repair or replacing.

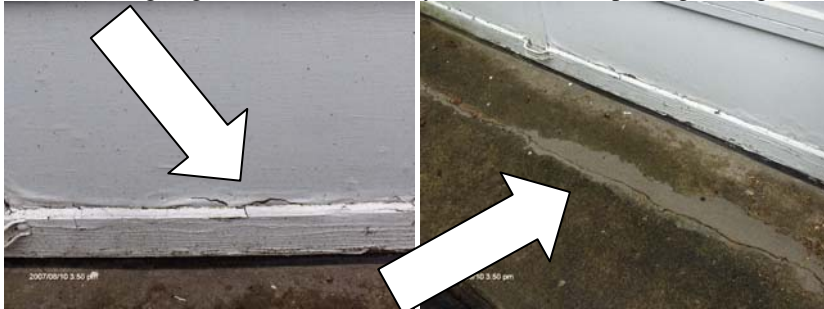
Trim around garage door s has some dry rot and needs replacing. Garage door had chipping paint and need repair.

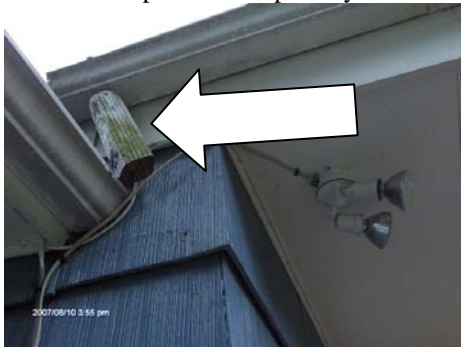
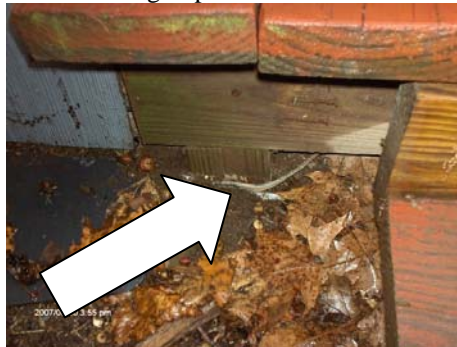
Concrete saddle of garage has cracked concrete and needs repair. Outlet in the rear of the home near SGD has reverse polarity and there was exposed romex noted in the front of home, these are Safety Concerns, recommend licensed electrician repair reverse polarity outlet and enclose wiring in plastic conduit as necessary.

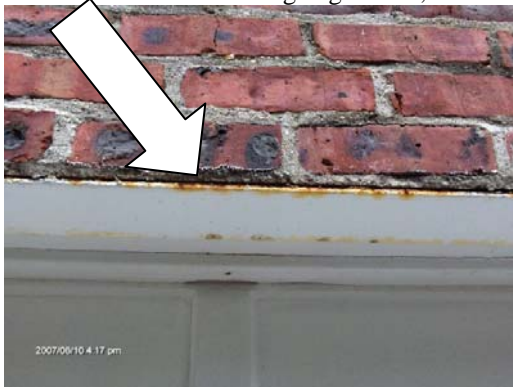
Rusted lintel noted above garage doors, recommend monitoring brick for signs of settlement in the future.

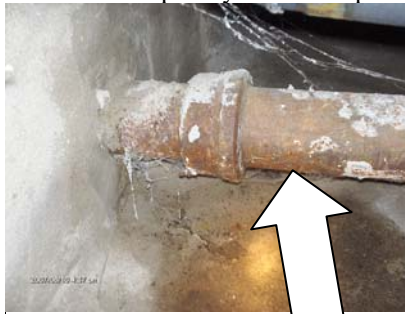
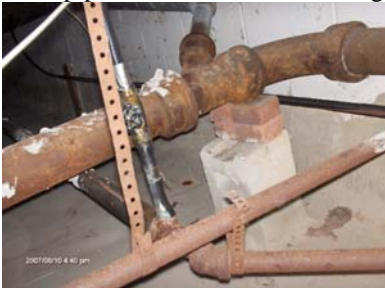
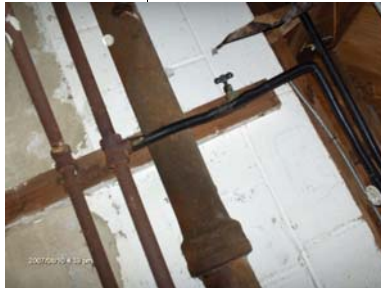
Main four inch waste pipe is leaking in crawl space and needs repair by a licensed plumber. Rust noted on cast iron

drain pipes, recommend monitoring in the future.

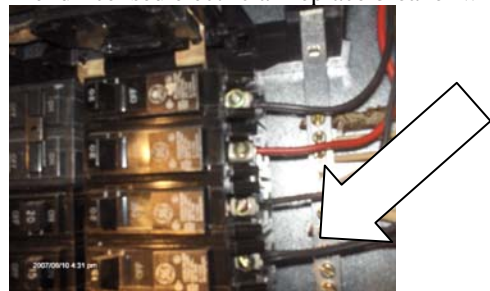
Panel size appeared to be compatible to service size. Double taping (2 wires on one lug) noted on one 15 amp breaker in main panel which is not a recommended practice. Recommend licensed electrician replace breaker with split

breaker to eliminate the need for double tapings as needed. Recommend replacing outlets in the garage, crawlspace, outside and any where within 6 feet of water with GFCI receptacles as needed.
