HOME INSPECTION REPORT

Street Address

Hawkeye Home Inspections

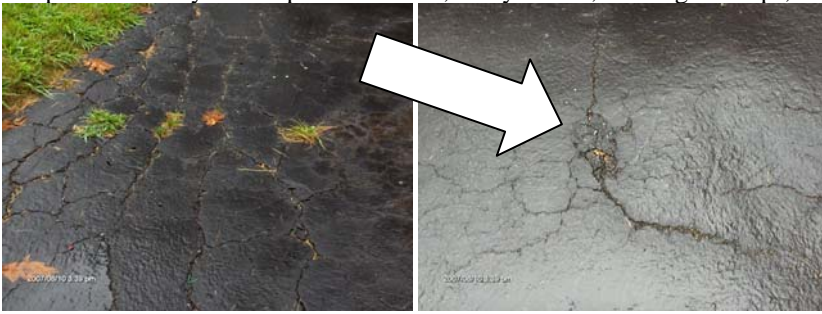
Asphalt driveway was in poor condition, many cracks, heaving and dips, recommend replacement as needed.

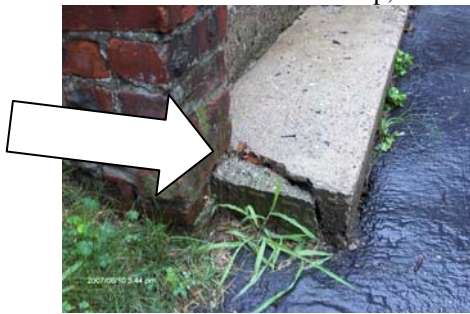
Broken concrete noted on step, recommend repair as needed.

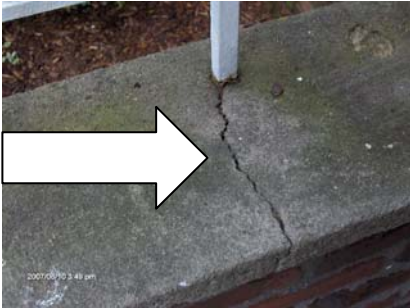
Front porch had a few cracks in concrete cap of wall and needs repair.

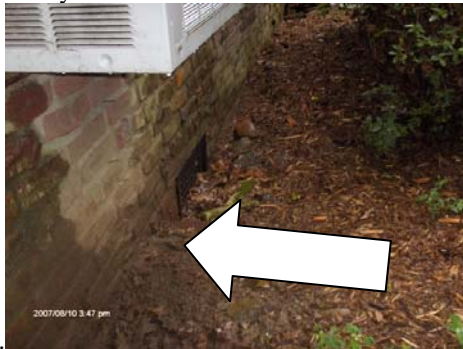
Deck posts were buried in the ground and should be monitored in the future for signs of rotting otherwise appeared to be in satisfactory condition. Low areas next to the foundation at the front left and rear right of home need some

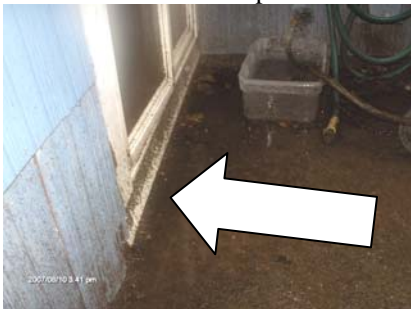
correction. Recommend additional backfill to create a proper pitch away from the house. Patio is pitched toward the home; recommend repair or replacement as needed.

Patios that have settled towards the structure should be mud jacked or replaced to assure proper pitch. Improperly pitched patios are one source of wet basements.

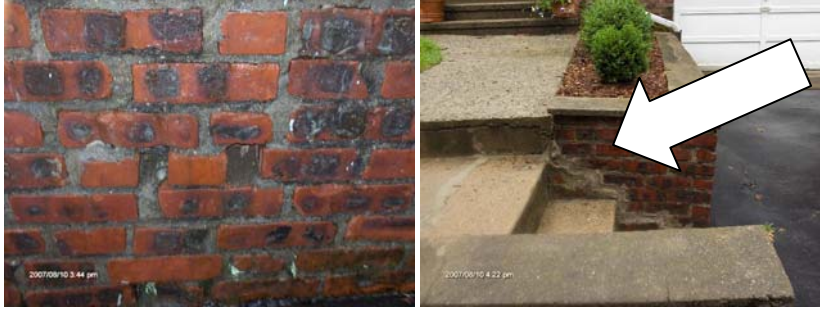
Brick retaining wall in the front of home is missing some mortar and leaning with a steps crack that had been patched, however appears structurally sufficient, recommend adding mortar where needed and monitoring in the future.

Retaining walls deteriorate because of excessive pressure buildup behind them, generally due to water accumulation. Often, conditions can be improved by excavating a trench behind the retaining wall and filling it with coarse gravel. Drain holes through the wall will then be able to relieve the water pressure.

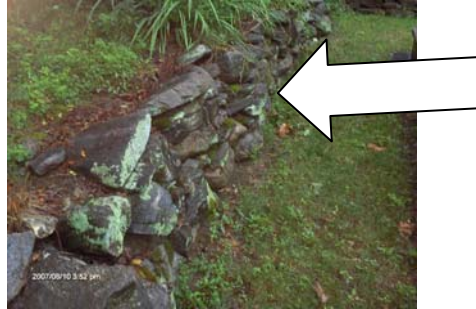
Stone retaining wall at the left of the home property has loose and displaced stones and needs rebuilding or

Replacing, ownership is unknown.

Retaining walls sometime suffer from tree root pressure or from general movement of topsoil down the slope. Normally, these conditions require rebuilding the retaining wall.

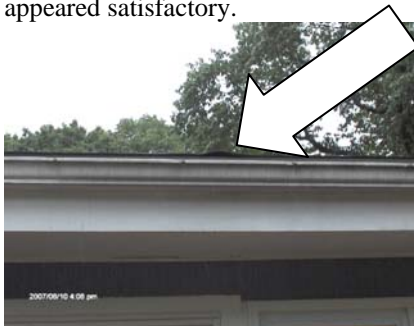
Roof coverings was lifted in one area at edge of flat roof in the rear of the home and needs reseating otherwise appeared satisfactory.

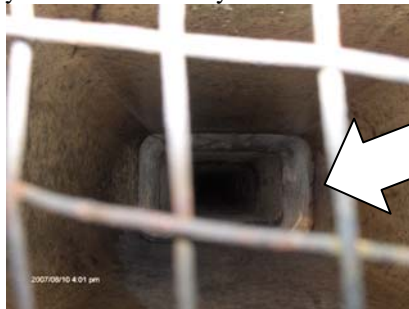
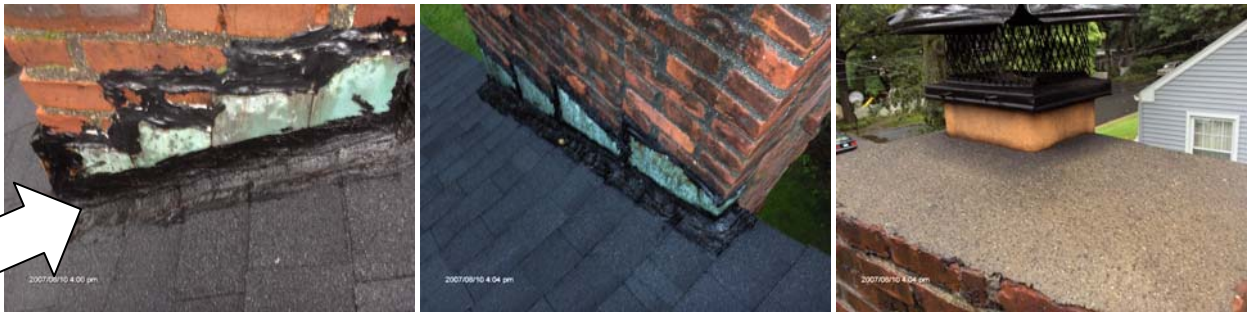
General Comments
 Concrete cap of chimney at the rear right of home is cracked, chase needs some minor re pointing and flue is cracked, and offset slightly, recommend repair by a licensed chimney technician as needed.

Chimneys built of masonry will eventually need tuck pointing. A cracked chimney top that allows water and carbonic acid to get behind the surface brick/stone will accelerate the deterioration. Moisture will also deteriorate the clay flue liner. Periodic chimney cleaning will keep you apprised of the chimney's condition. The flashing around the chimney may need resealing and should be inspected every year or two. Fireplace chimneys should be inspected and evaluated by a chimney professional before using. Chimneys must be adequate height for proper drafting. Spark arrestors are recommended for wood burning chimney and chimney caps for fossil fuels

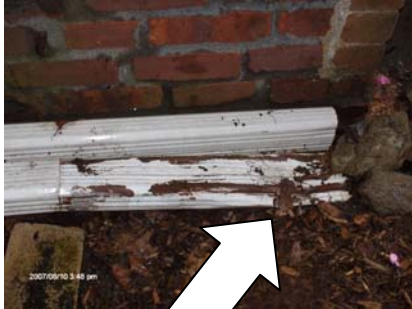
Leader extension was crushed in the front of the home and needs replacing.

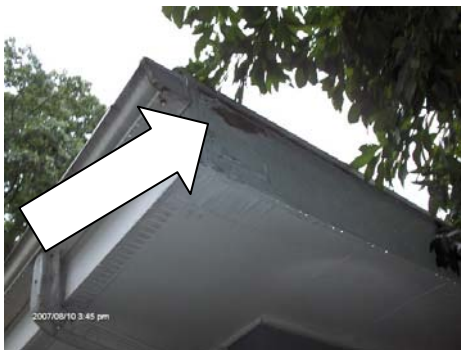
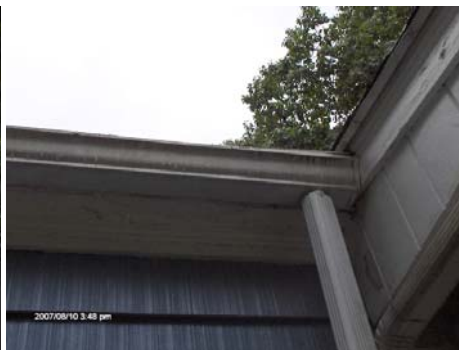
Some Ponding of water noted in gutters. Gutters may need some slight re pitching in a few areas. Siding had some dry rotted shingles at the rear left of home that need replacing from ground contact. Some screens are torn, repair as needed. Some wood trim boards, sills, soffit and fascia boards had chipping paint with some minor dry rot and need repair or replacing.

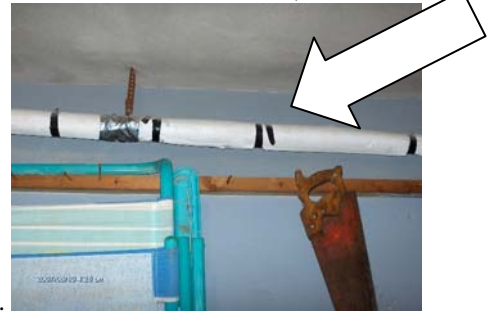
Garage door springs are missing safety cables, recommend installing cables through springs to prevent flying in the event breakage occurs. Pipe insulation in garage appears to be Asbestos which is a known Health Hazard, recommend

licensed Asbestos Abatement co. evaluate insulation and remove if necessary.

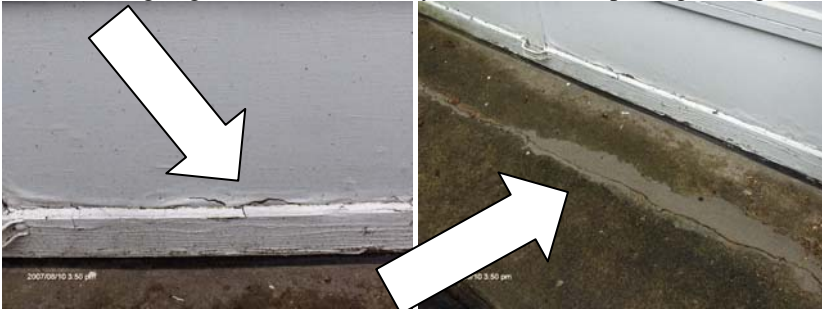
Trim around garage door s has some dry rot and needs replacing. Garage door had chipping paint and need repair.

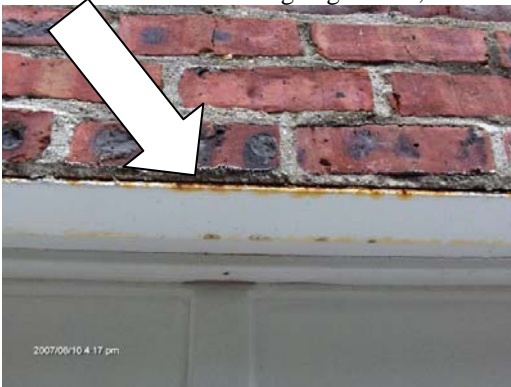
Rusted lintel noted above garage doors, recommend monitoring brick for signs of settlement in the future.

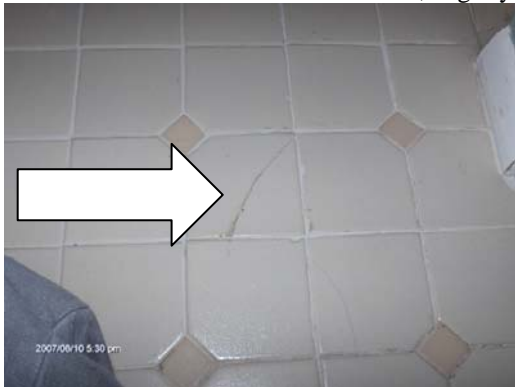
Drains show no signs of back-up during time of inspection. Some caulk needed at top of tub and around fixtures in bath tiles. A few floor tiles are cracked, slightly bulged and grout is missing, recommend repair as needed.

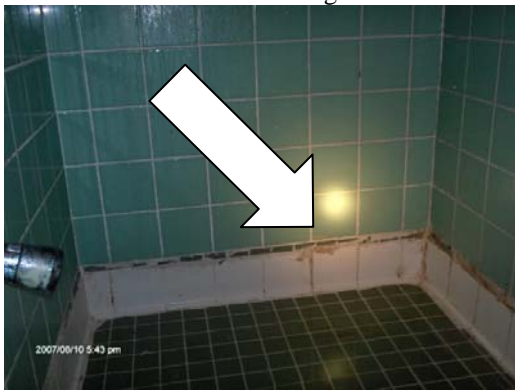
Drains show no signs of back-up during time of inspection. Tub hot water flow is marginal, recommend repair as needed. Some minor caulk or grout needed in shower tiles. Excessive caulk noted on shower tiles.

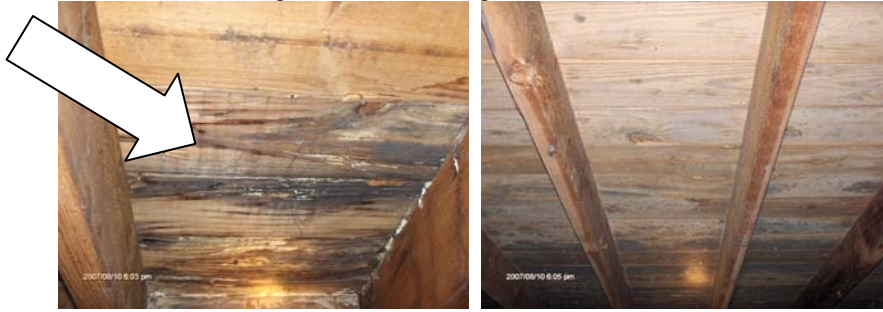
Rafters appeared to be in overall adequate condition. Sheathing, examined from the attic, had some water damage on sheathing with some sagging in the attic at the right side of home that should be counter supported with two by fours and some mold like growth on sheathing at lower sections near soffits in the front of home.

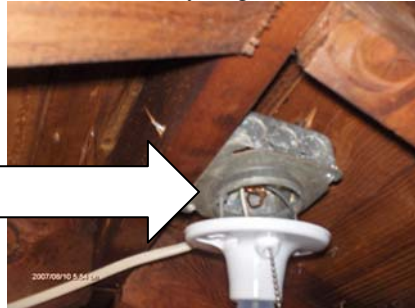
Ventilation was marginal and could be improved; recommend replacing whole house with fan controlled by thermostat and replacing powered vent with vent that remains open all the time at gable vent to aide ventilation as needed. Recommend pulling back any insulation at soffits that may be blocking vents. Chimney section in attic appeared to be in satisfactory condition. Insulation in attic is touching recessed lighting fixtures which can become very hot, recommend checking the fixtures for IC rating and pulling back insulation 4 inches if fixtures are not IC rated as necessary. Light fixture of attic on the right side is hanging down and needs to be secured to electrical box.

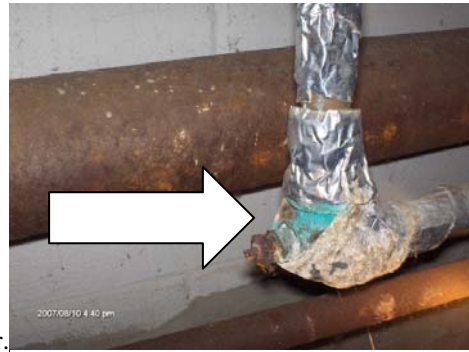
No active seepage visible at the time of the inspection. Recommend covering vents to prevent moisture from entering the crawl space. Recommend adding dehumidifier to aide moisture control as needed.
 (Continued next page)

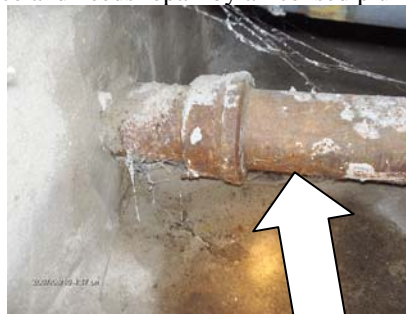
Main four inch waste pipe is leaking in crawl space and needs repair by a licensed plumber. Rust noted on cast iron

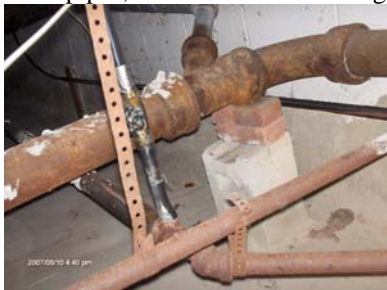
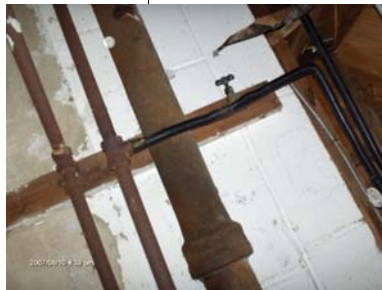
drain pipes, recommend monitoring in the future.

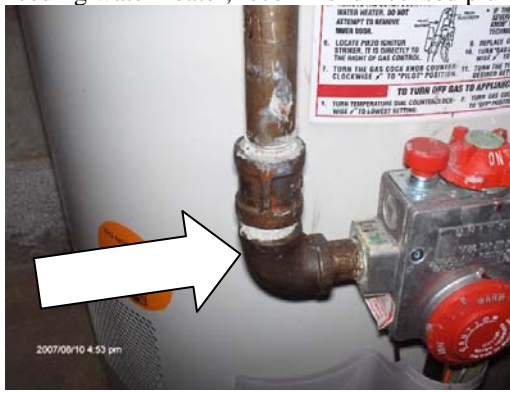
Drip leg is missing on gas line feeding water heater, recommend licensed plumber add drip leg to prevent sediment

build up in gas line as needed.

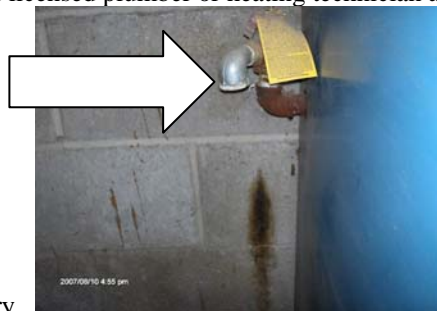
Boiler pressure and temperature at gauge were higher than normal; approx. 22PSI and 160 degrees, recommend further evaluation by a licensed heating technician as necessary. Boiler pressure relief valve extension pipe is missing, this is a Safety Concern, recommend licensed plumber or heating technician add relief valve extension pipe extending

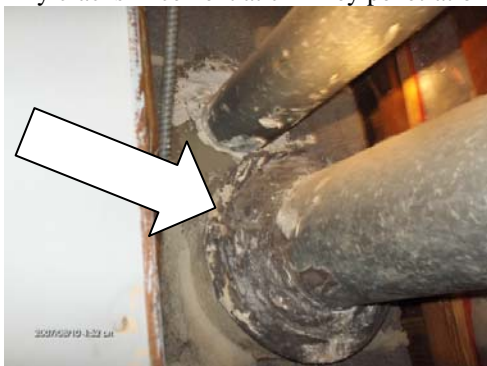
4-6 inches from the floor as necessary. Any cracks in cement at chimney penetration should be sealed with refractory cement.
